## Wind Mitigation Inspection

### Perico Bay Club, The Villages

605,607,609,611, 613,615,617,619 Estuary Dr, Building 1  
Bradenton FL, 34209

08/10/2023

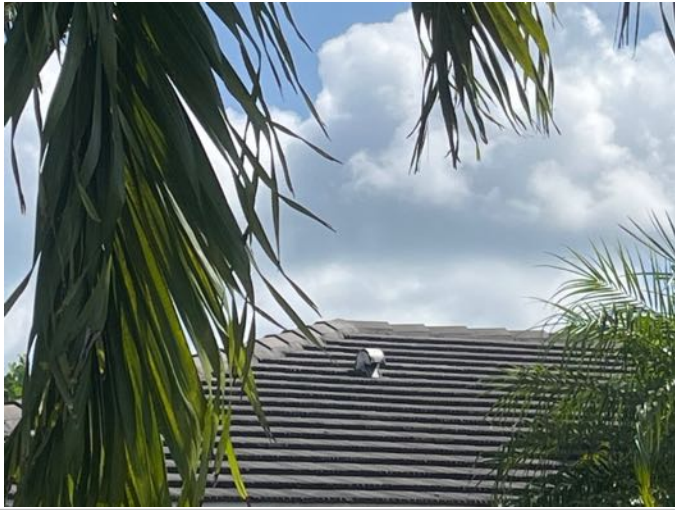
| 2.1 Roof Covering Type: | Permit Application Date | FBC or MDC Product Approval # | Year of Original Installation or Replacement | No Information Provided for Compliance |
|---|---|---|---|---|
| <input checked="" type="checkbox"/> 2. Concrete/Clay Tile | 03/06/2003 | 0300960 03/06/2003 | _____ | <input type="checkbox"/> |

- ☒ A. All roof coverings listed above meet the FBC with a FBC or Miami-Dade Product Approval listing current at time of installation OR have a roofing permit application date on or after 3/1/02 OR the roof is original and built in 2004 or later.

Roof Covering

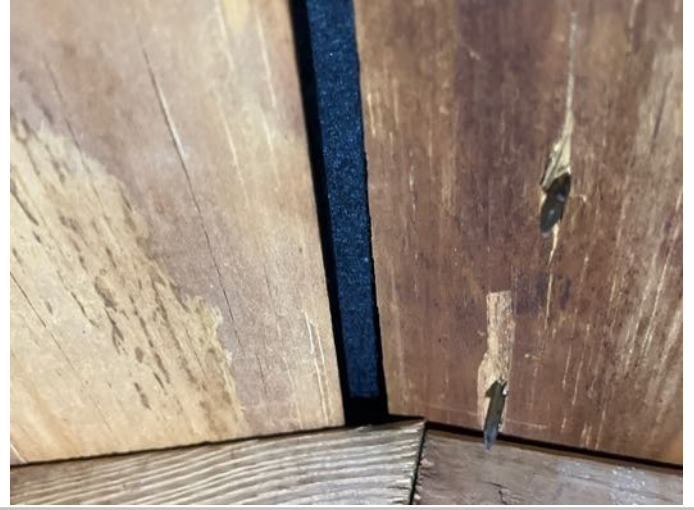
- ☒ C. Plywood/OSB roof sheathing with a minimum thickness of 7/16" inch attached to the roof truss/rafter (spaced a maximum of 24" inches o.c.) by 8d common nails spaced a maximum of 6" inches in the field. -OR- Dimensional lumber/Tongue & Groove decking with a minimum of 2 nails per board (or 1 nail per board if each board is equal to or less than 6 inches in width). -OR- Any system of screws, nails, adhesives, other deck fastening system or truss/rafter spacing that is shown to have an equivalent

Decking

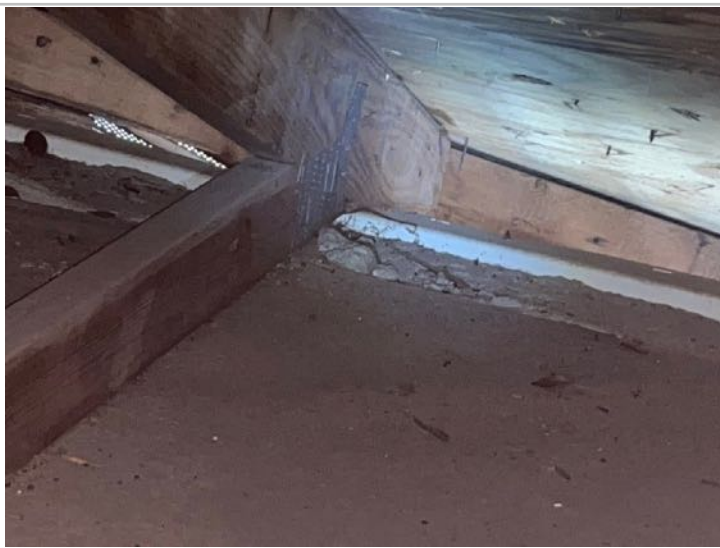
- ☒ Secured to truss/rafter with a minimum of three (3) nails, **and**
- ☒ Attached to the wall top plate of the wall framing, or embedded in the bond beam, with less than a ½" gap from the blocking or truss/rafter **and** blocked no more than 1.5" of the truss/rafter, **and** free of visible severe corrosion.
- ☒ B. Clips
  - ☒ Metal connectors that do not wrap over the top of the truss/rafter, **or**
  - ☐ Metal connectors with a minimum of 1 strap that wraps over the top of the truss/rafter and does not meet the nail position requirements of C or D, but is secured with a minimum of 3 nails.
- ☐ C. Single Wraps

Clip

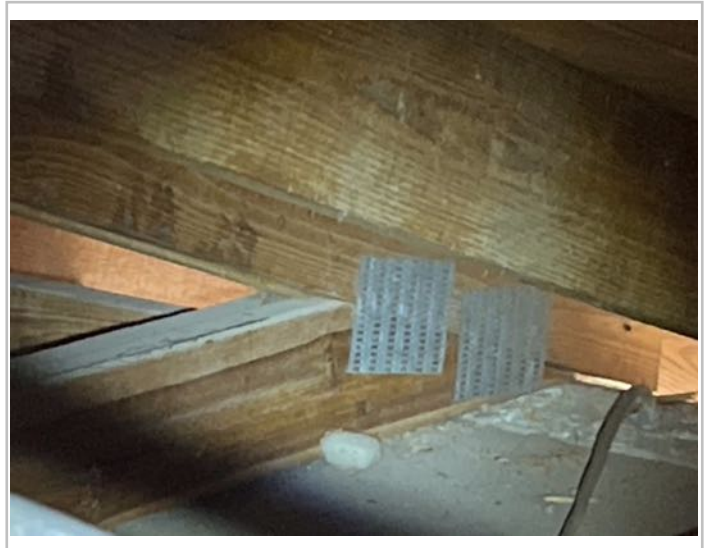
Opposing side

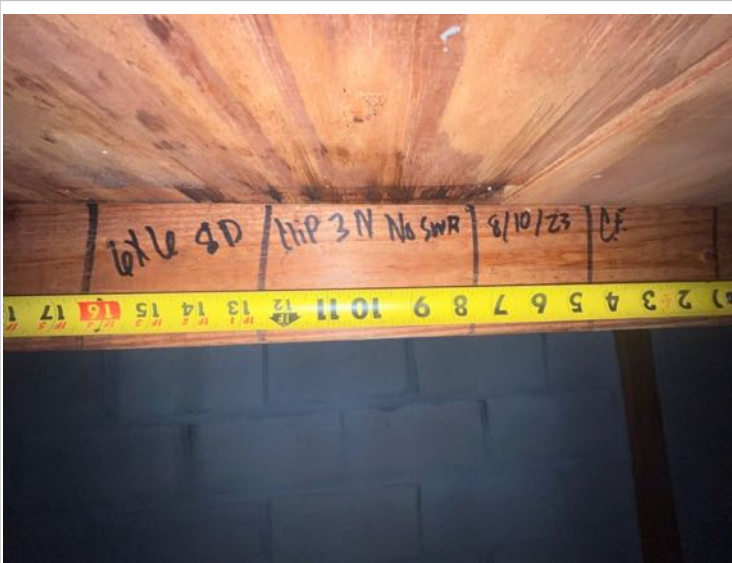
Spacing
