## Wind Mitigation Inspection

### Perico Bay Club, The Villages

610,612,614,616,618,620,622,624 Estuary Dr, Building 2  
Bradenton FL, 34209

08/10/2023

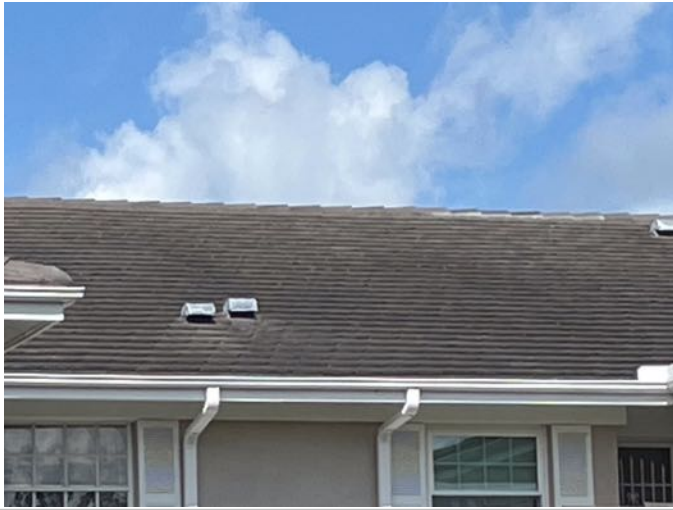
Roof Covering

| 2.1 Roof Covering Type: | Permit Application Date | FBC or MDC Product Approval # | Year of Original Installation or Replacement | No Information Provided for Compliance |
|---|---|---|---|---|
| <input checked="" type="checkbox"/> 2. Concrete/Clay Tile | 03/06/2003 | 0300957 03/06/2003 | _____ | <input type="checkbox"/> |

- ☒ A. All roof coverings listed above meet the FBC with a FBC or Miami-Dade Product Approval listing current at time of installation OR have a roofing permit application date on or after 3/1/02 OR the roof is original and built in 2004 or later.

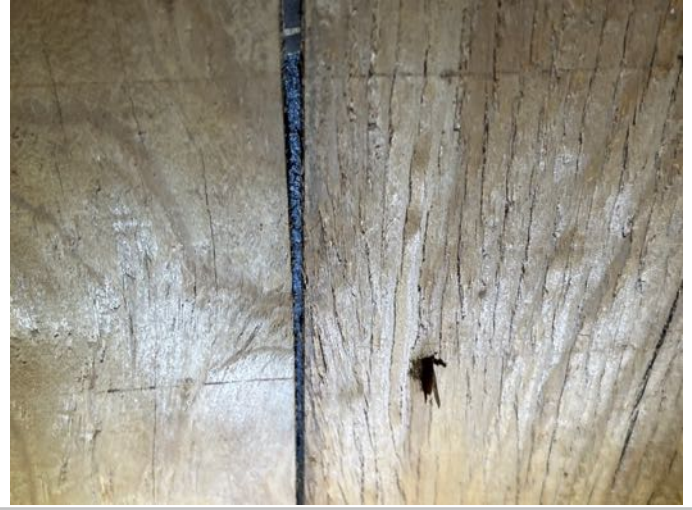
Decking

- ☒ C. Plywood/OSB roof sheathing with a minimum thickness of 7/16" inch attached to the roof truss/rafter (spaced a maximum of 24" inches o.c.) by 8d common nails spaced a maximum of 6" inches in the field. -OR- Dimensional lumber/Tongue & Groove decking with a minimum of 2 nails per board (or 1 nail per board if each board is equal to or less than 6 inches in width). -OR- Any system of screws, nails, adhesives, other deck fastening system or truss/rafter spacing that is shown to have an equivalent

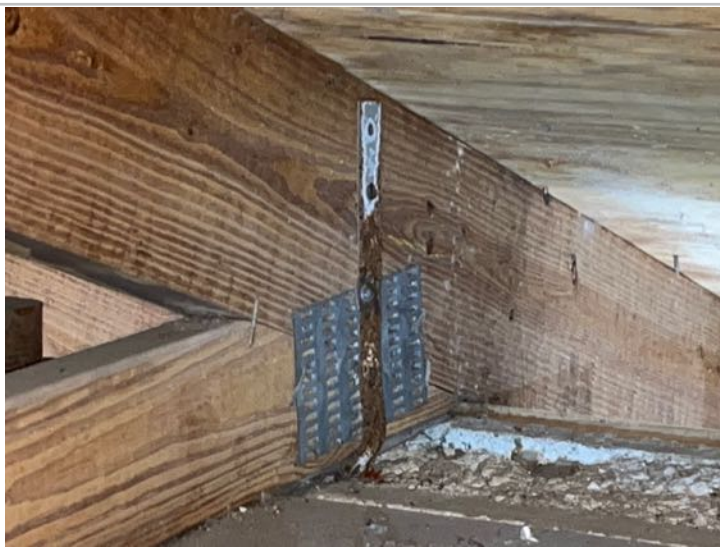
Clip

- ☒ B. Clips
  - ☒ Metal connectors that do not wrap over the top of the truss/rafter, **or**
  - ☐ Metal connectors with a minimum of 1 strap that wraps over the top of the truss/rafter and does not meet the nail position requirements of C or D, but is secured with a minimum of 3 nails.
