## Wind Mitigation Inspection

### Perico Bay Club, The Villages

702,702,706,708,710,712,714,716 Estuary Dr, Building 6  
Bradenton FL, 34209

# Uniform Mitigation Verification Inspection Form

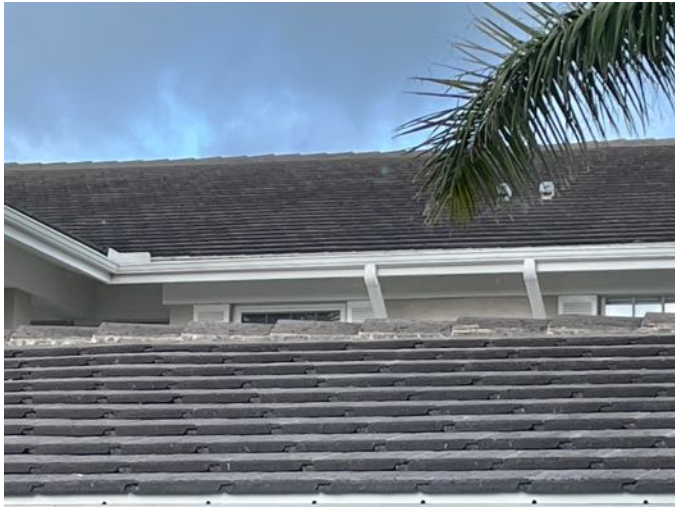
Roof Covering

| 2.1 Roof Covering Type: | Permit Application Date | FBC or MDC Product Approval # | Year of Original Installation or Replacement | No Information Provided for Compliance |
|---|---|---|---|---|
| <input checked="" type="checkbox"/> 2. Concrete/Clay Tile | 03/06/2003 | 0300963 03/06/2003 | ____ | <input type="checkbox"/> |

- ☒ A. All roof coverings listed above meet the FBC with a FBC or Miami-Dade Product Approval listing current at time of installation OR have a roofing permit application date on or after 3/1/02 OR the roof is original and built in 2004 or later.

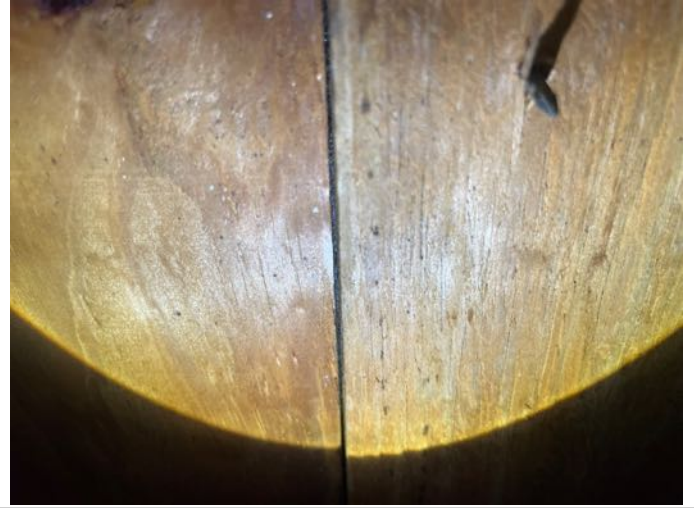
Decking

- ☒ C. Plywood/OSB roof sheathing with a minimum thickness of 7/16" inch attached to the roof truss/rafter (spaced a maximum of 24" inches o.c.) by 8d common nails spaced a maximum of 6" inches in the field. -OR- Dimensional lumber/Tongue & Groove decking with a minimum of 2 nails per board (or 1 nail per board if each board is equal to or less than 6 inches in width). -OR- Any system of screws, nails, adhesives, other deck fastening system or truss/rafter spacing that is shown to have an equivalent

or greater resistance than 8d common nails spaced a maximum of 6 inches in the field or has a mean uplift resistance of at least 182 psf.

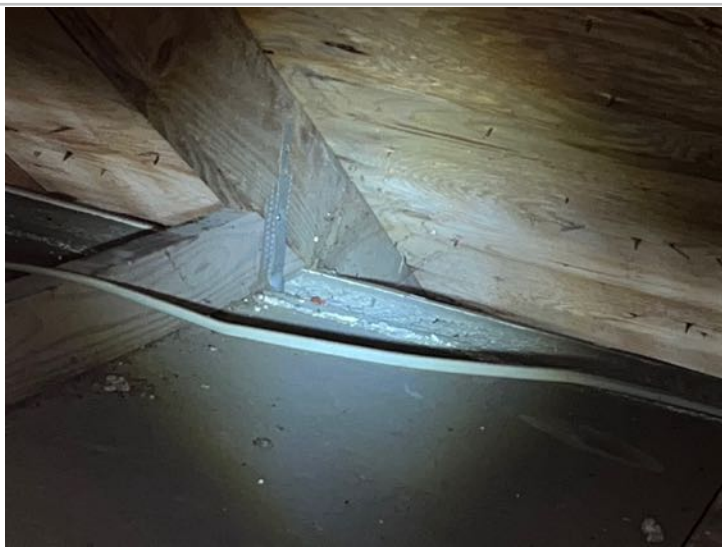
Clip

- ☒ Secured to truss/rafter with a minimum of three (3) nails, **and**
- ☒ Attached to the wall top plate of the wall framing, or embedded in the bond beam, with less than a ½" gap from the blocking or truss/rafter **and** blocked no more than 1.5" of the truss/rafter, **and** free of visible severe corrosion.

- ☒ B. Clips
  - ☒ Metal connectors that do not wrap over the top of the truss/rafter, **or**
  - ☐ Metal connectors with a minimum of 1 strap that wraps over the top of the truss/rafter and does not meet the nail position requirements of C or D, but is secured with a minimum of 3 nails.
