## Wind Mitigation Inspection

### Perico Bay Club, The Villages

703,705,707,709,711,713,715,717 Estuary Dr, Building 5  
Bradenton FL, 34209

08/10/2023

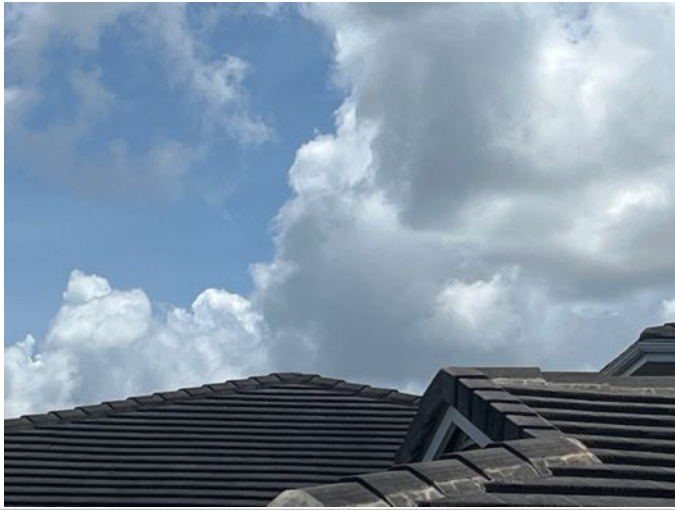
| 2.1 Roof Covering Type: | Permit Application Date | FBC or MDC Product Approval # | Year of Original Installation or Replacement | No Information Provided for Compliance |
|---|---|---|---|---|
| <input checked="" type="checkbox"/> 2. Concrete/Clay Tile | 03/06/2003 | 0300958 03/06/2003 | ____ | <input type="checkbox"/> |

Roof Covering

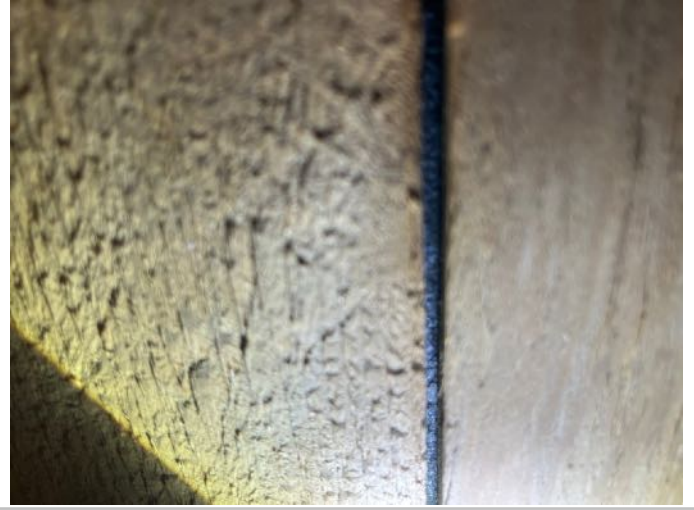
- ☒ C. Plywood/OSB roof sheathing with a minimum thickness of 7/16" inch attached to the roof truss/rafter (spaced a maximum of 24" inches o.c.) by 8d common nails spaced a maximum of 6" inches in the field. -OR- Dimensional lumber/Tongue & Groove decking with a minimum of 2 nails per board (or 1 nail per board if each board is equal to or less than 6 inches in width). -OR- Any system of screws, nails, adhesives, other deck fastening system or truss/rafter spacing that is shown to have an equivalent

Decking

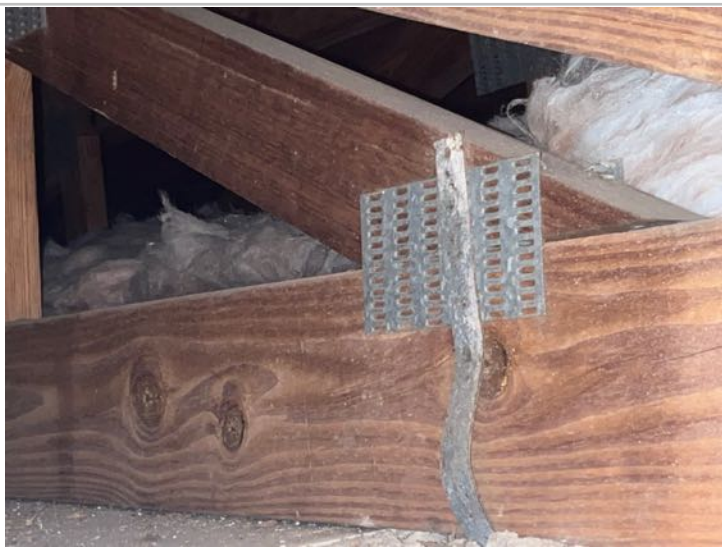
- ☒ B. Clips
  - ☒ Metal connectors that do not wrap over the top of the truss/rafter, **or**
  - ☐ Metal connectors with a minimum of 1 strap that wraps over the top of the truss/rafter and does not meet the nail position requirements of C or D, but is secured with a minimum of 3 nails.

Clip

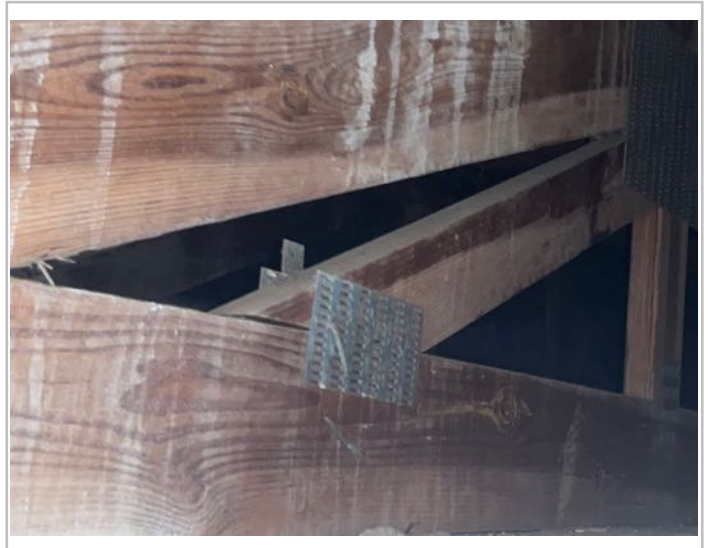
Opposing side

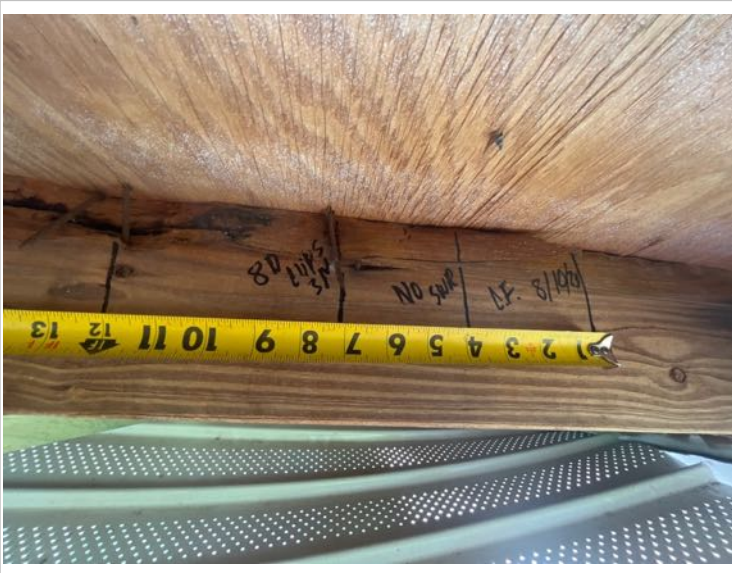
Spacing

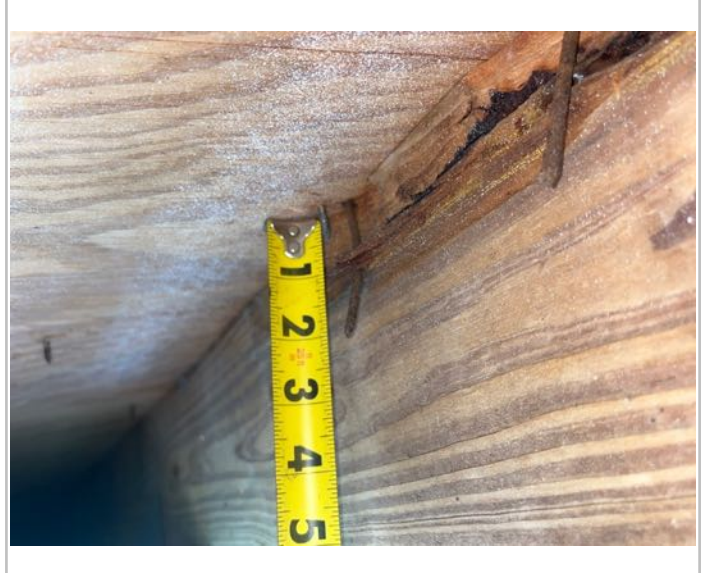
8d Nails
