## Wind Mitigation Inspection

### Perico Bay Club, The Villages

718,720,722,724,726,728,730,732 Estuary Dr, Building 8  
Bradenton FL, 34209

08/10/2023

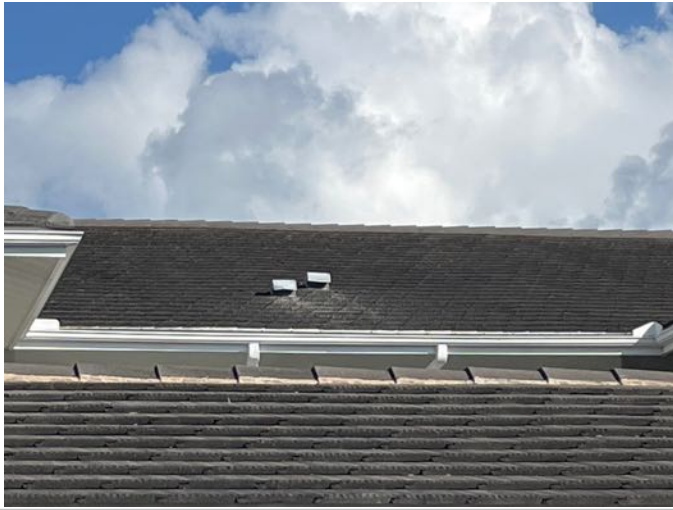
Roof Covering

| 2.1 Roof Covering Type: | Permit Application Date | FBC or MDC Product Approval # | Year of Original Installation or Replacement | No Information Provided for Compliance |
|---|---|---|---|---|
| <input checked="" type="checkbox"/> 2. Concrete/Clay Tile | ____/____/____ | 0300963 03/06/2003 | _____ | <input type="checkbox"/> |

- ☒ A. All roof coverings listed above meet the FBC with a FBC or Miami-Dade Product Approval listing current at time of installation OR have a roofing permit application date on or after 3/1/02 OR the roof is original and built in 2004 or later.

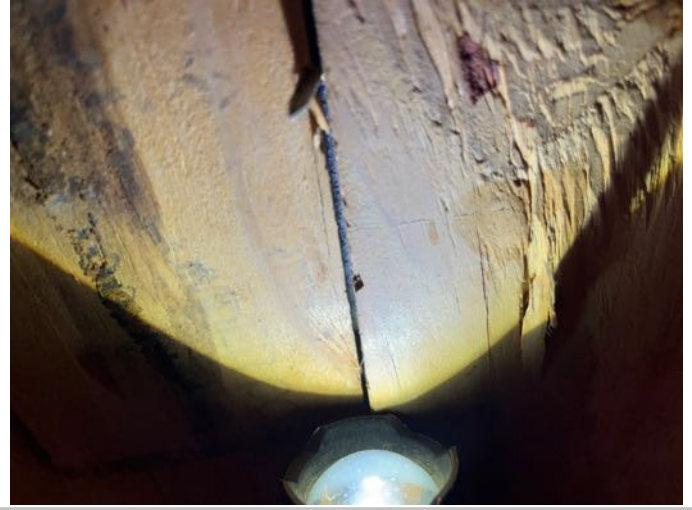
Decking

- ☒ C. Plywood/OSB roof sheathing with a minimum thickness of 7/16" inch attached to the roof truss/rafter (spaced a maximum of 24" inches o.c.) by 8d common nails spaced a maximum of 6" inches in the field. -OR- Dimensional lumber/Tongue & Groove decking with a minimum of 2 nails per board (or 1 nail per board if each board is equal to or less than 6 inches in width). -OR- Any system of screws, nails, adhesives, other deck fastening system or truss/rafter spacing that is shown to have an equivalent

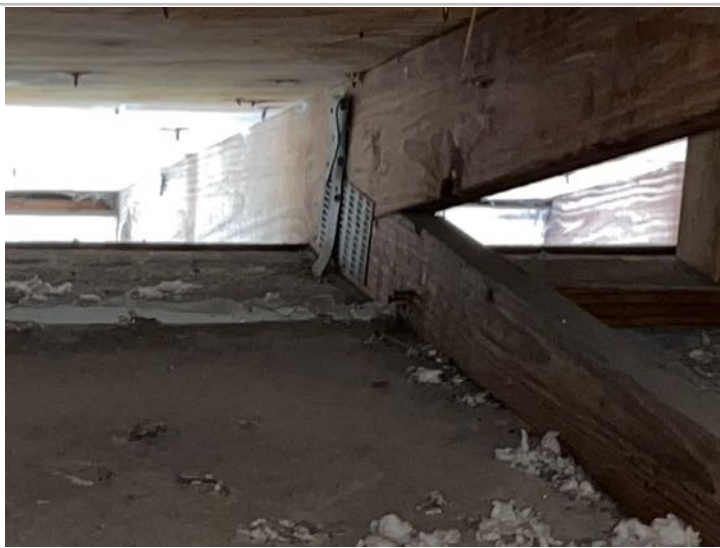
Clip

- ☒ Secured to truss/rafter with a minimum of three (3) nails, **and**
- ☒ Attached to the wall top plate of the wall framing, or embedded in the bond beam, with less than a ½" gap from the blocking or truss/rafter **and** blocked no more than 1.5" of the truss/rafter, **and** free of visible severe corrosion.

- ☒ B. Clips
  - ☒ Metal connectors that do not wrap over the top of the truss/rafter, **or**
  - ☐ Metal connectors with a minimum of 1 strap that wraps over the top of the truss/rafter and does not meet the nail position requirements of C or D, but is secured with a minimum of 3 nails.
