## Wind Mitigation Inspection

### Perico Bay Club, The Villages

719,721,723,725,727,729,731,733 Estuary Dr, Building 7  
Bradenton FL, 34209

08/10/2023

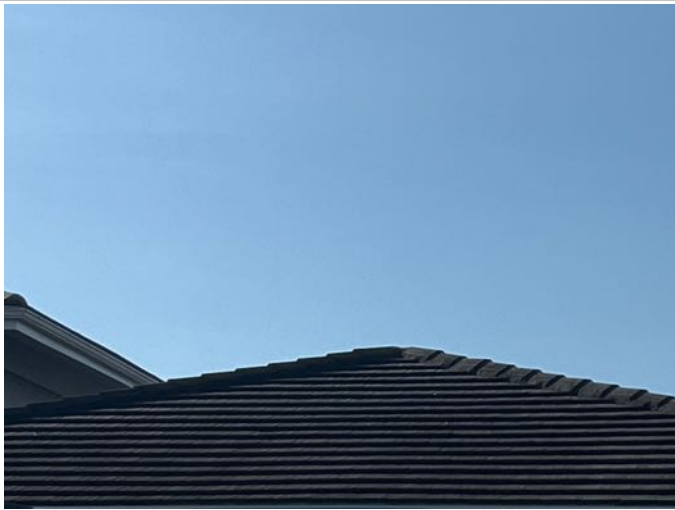
Roof Covering

| 2.1 Roof Covering Type: | Permit Application Date | FBC or MDC Product Approval # | Year of Original Installation or Replacement | No Information Provided for Compliance |
|---|---|---|---|---|
| <input checked="" type="checkbox"/> 2. Concrete/Clay Tile | 03/06/2003 | 0300963 03/06/2003 | ____ | <input type="checkbox"/> |

- ☒ A. All roof coverings listed above meet the FBC with a FBC or Miami-Dade Product Approval listing current at time of installation OR have a roofing permit application date on or after 3/1/02 OR the roof is original and built in 2004 or later.

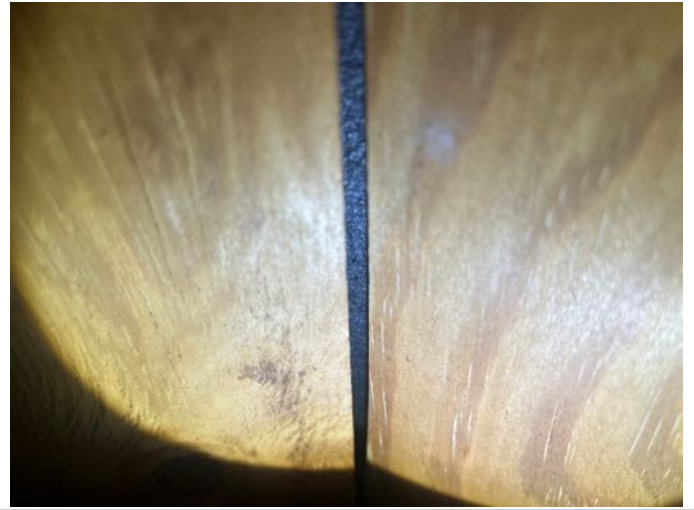
Decking

- ☒ C. Plywood/OSB roof sheathing with a minimum thickness of 7/16" inch attached to the roof truss/rafter (spaced a maximum of 24" inches o.c.) by 8d common nails spaced a maximum of 6" inches in the field. -OR- Dimensional lumber/Tongue & Groove decking with a minimum of 2 nails per board (or 1 nail per board if each board is equal to or less than 6 inches in width). -OR- Any system of screws, nails, adhesives, other deck fastening system or truss/rafter spacing that is shown to have an equivalent

or greater resistance than 8d common nails spaced a maximum of 6 inches in the field or has a mean uplift resistance of at least 182 psf.

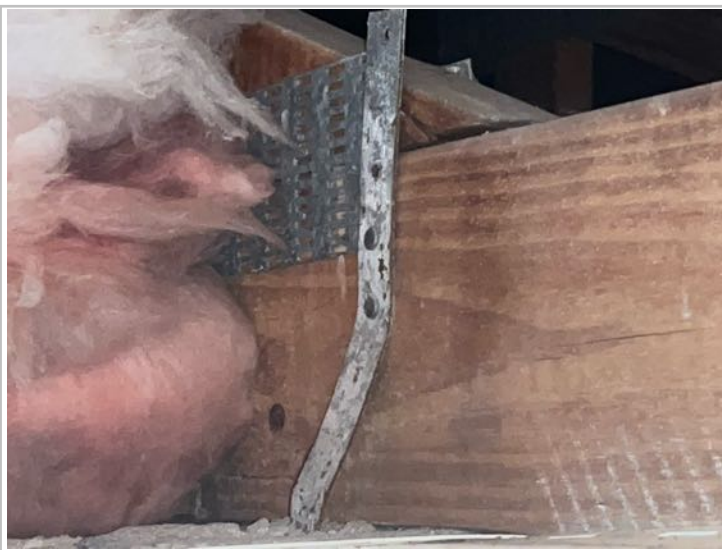
Clip

- ☒ Secured to truss/rafter with a minimum of three (3) nails, **and**
- ☒ Attached to the wall top plate of the wall framing, or embedded in the bond beam, with less than a ½" gap from the blocking or truss/rafter **and** blocked no more than 1.5" of the truss/rafter, **and** free of visible severe corrosion.

- ☒ B. Clips
  - ☒ Metal connectors that do not wrap over the top of the truss/rafter, **or**
  - ☐ Metal connectors with a minimum of 1 strap that wraps over the top of the truss/rafter and does not meet the nail position requirements of C or D, but is secured with a minimum of 3 nails.
